# SALT CRUST

Nostra Senyora del Remei Chapel. Monastery of Aviganya. LLeida. Spain.

# **Pathology Causes**

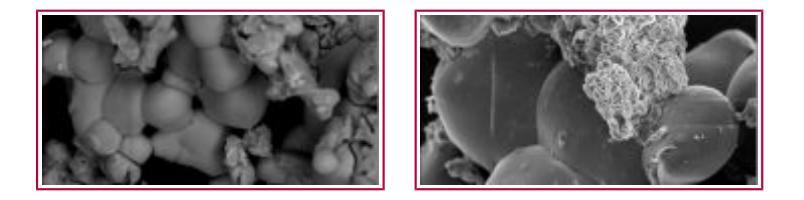
# Microscope Image

Author: CETEC-patrimoni Magnification: Figure 1. x750. Figure 2. x1000 - SEM-BSEI Description:

Sub-rounded and amoeboid crystal habits indicate that the salts have grown in a very wet wall in direct contact with moisture. Their tendency to cluster in nodules indicates long repeated cycles of crystallization, mainly linked to seasonal changes and different periods of rain. Flaking. Sanding. Blistering.

Alveolization.

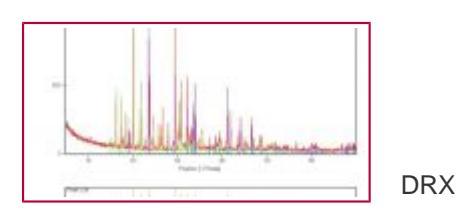
# **Other Tests**

Potassium nitrates and other alkali salts (niter) and magnesium sulphates (hexaedrite).
